**DEPARTMENT OF TRANSPORTATION****DIVISION OF ENGINEERING SERVICES**

Quality Assurance and Source Inspection

Contract #: 04-0120F4Cty: SF/ALA Rte: 80 PM: 13.2/13.9File #: 69.28**WELDING INSPECTION REPORT****Resident Engineer:**Pursell, Gary**Address:** 333 Burma Road**City:** Oakland, CA 94607**Report No:** WIR-000529**Date Inspected:** 27-Sep-2007**Project Name:** SAS Superstructure**OSM Arrival Time:** 2330**Prime Contractor:** American Bridge/Fluor Enterprises, a JV**OSM Departure Time:** 800**Contractor:** Zhenhua Port Machinery Company, Ltd (ZPMC), Changxing Island **Location:** Shanghai, China**CWI Name:** Huang Li & Xu Lefeng**CWI Present:** Yes No**Inspected CWI report:** Yes No N/A**Rod Oven in Use:** Yes No N/A**Electrode to specification:** Yes No N/A**Weld Procedures Followed:** Yes No N/A**Qualified Welders:** Yes No N/A**Verified Joint Fit-up:** Yes No N/A**Approved Drawings:** Yes No N/A**Approved WPS:** Yes No N/A**Delayed / Cancelled:** Yes No N/A**Bridge No:** 34-0006**Component:** Caltrans Mockup**Summary of Items Observed:**

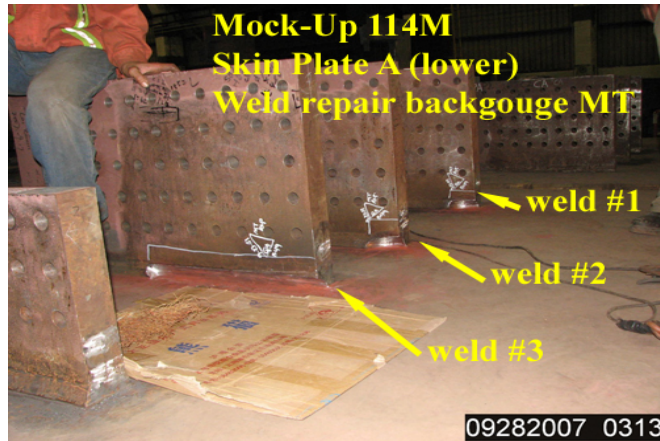
Item	Description	WBS	Dwg No.	Status
1	Skin Plate A (lower)	NA	NA	ZPMC MT

Mock-Up 114M, Skin Plate A (lower): Caltrans QA Inspector witnessed ZPMC Quality Control technician, Mr. Zhou Dongyan perform magnetic particle test (MT) at complete joint penetration (CJP), weld repair backgouge. The locations are identified as stiffener plate mp1002, weld map number 1, 2 and 3 to skin plate MA107. The length of the weld repair excavation area measured 98 mm for weld 1, 90 mm for weld 2 and 500 mm for weld 3. The weld repairs were inspected and accepted by QC. The MT appeared to be in compliance with the project specification. Following digital picture illustrates the MT weld repair backgouges

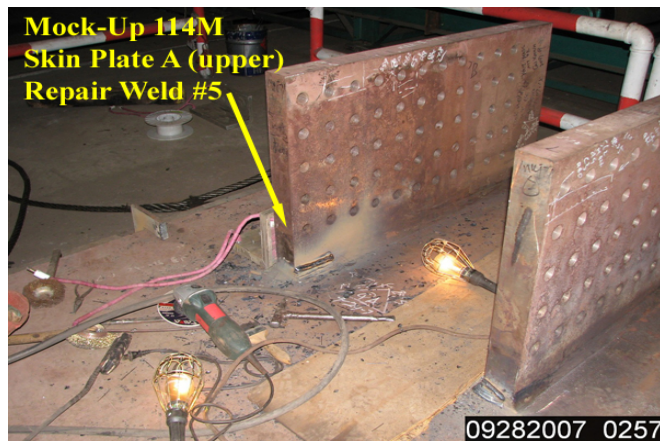
| 2 | Skin Plate A (upper) | NA | NA | Weld Repair |

Mock-Up 114M, Skin Plate A (upper): Caltrans QA Inspector observed flux cored arc welding (FCAW) in progress at stiffener plate, mp1002-2, weld number 5 (weld repair) to skin plate MA106, complete joint penetration (CJP), double bevel T-joint weld. The welder is observed welding fill/cover pass weld in the horizontal position. Caltrans QA Inspector observed welder chipping and wire brushing during the interpass weld cleaning. The welder is identified as Mr. Jiang Zhou, welder stamp 040261. The welder is using welding procedure specification WPS-345-FCAW-2G (2F)-Repair, Revision 1. Caltrans QA Inspector observed ZPMC Quality Control (QC) Certified Welding Inspector (CWI) Mr. Xu Lefeng and Bureau Veritas inspector, Mr. Huang Li monitoring welding activities at the workstation. Caltrans QA Inspector measured current welding parameters at approximately 310 amps, 30.0 volts and 305 millimeters per minute (mm/min) travel speed. Preheat and interpass temperatures were verified during welding activities. The preheat temperature prior to the start of welding measures more than 160 Celsius (320 degree Fahrenheit) but less than 232 Celsius (450 degrees Fahrenheit) during maximum interpass temperature verification. FCAW consumable is verified and identified as Supercored 71H, classification E71T-1, diameter 1.4 mm (.055 inches). Following digital picture illustrates completed weld repair.

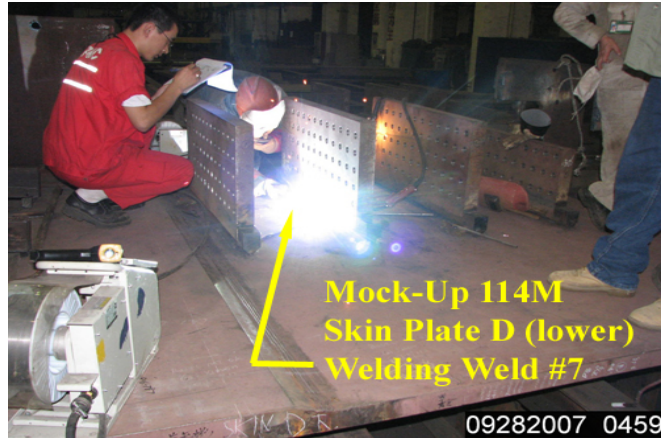
| 3 | Skin Plate D (lower) | NA | NA | Work In Progress |

Mock-Up 114M, Skin Plate D (lower): Caltrans QA Inspector observed flux cored arc welding (FCAW) in progress at stiffener plate, mp1011 to skin plate MA110, partial joint penetration (PJP), double bevel T-joint. The weld number is identified as weld 7. The welder is observed welding fill pass weld in the horizontal position. Caltrans QA Inspector observed welder chipping and wire brushing during the interpass weld cleaning. The welder is identified as Mr. Jiang Zhou, welder stamp 040261. The welder is using welding procedure specification WPS-B-T-2332-TC-P5-F, Revision 0. Caltrans QA Inspector observed ZPMC Quality Control (QC) Certified Welding Inspector (CWI) Mr. Xu Lefeng

and Bureau Veritas inspector, Mr. Huang Li monitoring welding activities at the workstation. Caltrans QA Inspector measured current welding parameters at approximately 300 amps, 32 volts and 305 millimeters per minute (mm/min) travel speed. Preheat and interpass temperatures were verified during welding activities. The preheat temperature prior to the start of welding measures more than 110 Celsius (230 degree Fahrenheit) but less than 232 Celsius (450 degrees Fahrenheit) during maximum interpass temperature verification. FCAW consumable is verified and identified as Supercored 71H, classification E71T-1, diameter 1.4 mm (.055 inches).
